Problem Solving Boiler Room Inefficiencies

Fairbank First Church of the Nazarene
Fairbanks, Alaska

Boiler Room Optimization

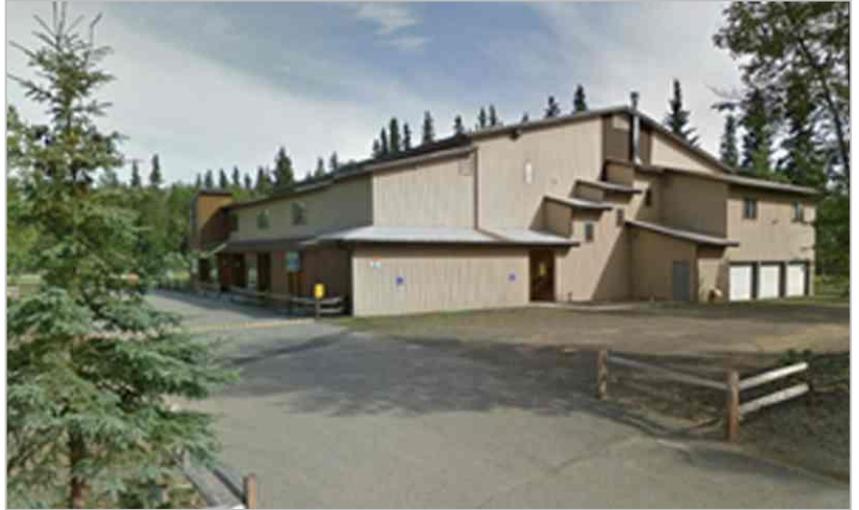
Nathan White prides himself on solving problems. It explains why he pursued engineering as a career and why most of White's business is retrofits. Nathan explains the boiler room complexities and how he solved the heating issues at Fairbanks First Church of the Nazarene: "This old church we were asked to look at was a challenge. Though the original 25 year old boiler was still putting out sufficient heat, the continual failure of pumps, zone valves and other components was not adding up. That wasn't all. The church said the heating bills were increasing each year. As it turned out we found the culprit to all the problems was simple: oxygen!"

A simple cause to the problem, but not so simple of a solution. The building had existing radiant floors in which the oxygen barrier in the tubing had failed. Commented White, "Oxygen just kept migrating through the tube walls into the fluid. The brackish colored water was the first tell-tale sign. Another type of air separator was being used but was insufficient in preventing rust and sludge from forming and causing binding of the pumps and clogging of the control valves. We determined it was too expensive to tear up the floors and replace the tubing", said White. "This type of rubber tubing isn't manufactured anymore because of this issue. Because the system was consistently run at low radiant temperatures, the tubing was still flexible and we felt had sufficient life left. If we could provide a solution to rid oxygen quicker and inhibit the ongoing debris and rust formation, we could minimize maintenance expenses for the Church".

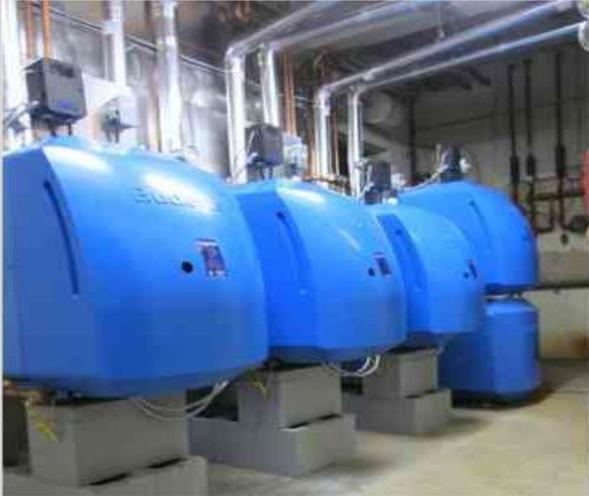
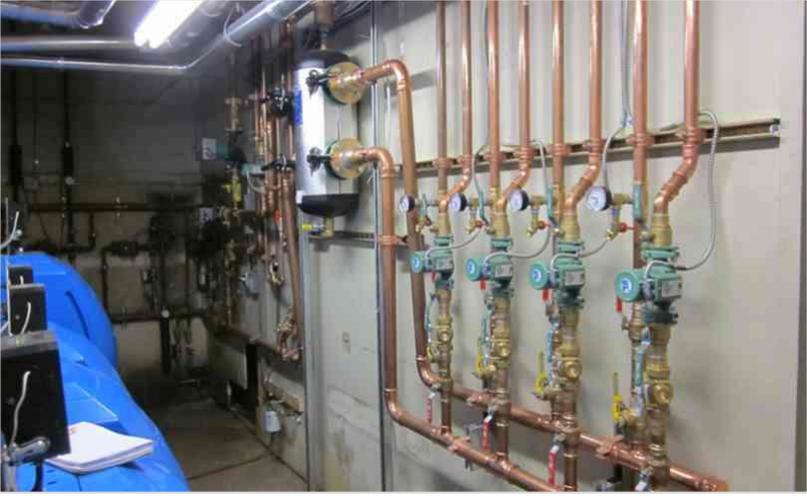
The flow rating of each boiler was less than the total system flow at design conditions. "Though the boilers were a relatively large mass versus a condensing boiler, their size required us to go with primary/secondary piping. We put in a 4" Caleffi HydroCal which provided not only hydraulic separation but also substantially increased the air removal efficiency and added high efficiency dirt capture. With the proper flow going through them, those blue flame Buderus boilers could achieve their high efficiency rating."

Lastly, because of high electricity costs, ECM pumps were placed on the secondary loops. Said White, "Because we knew some oxide would continue forming, we wanted to insure long life for the pumps. We installed a DIRTMAG on each system loop to ensure oxide was captured rather than allowed to create future problems."
