CASE STUDY

WATER QUALITY UPDATE PROTECTS SCHOOL MECHANICAL SYSTEM PROJECT AT-A-GLANCE

Location:	High School, Kansas
Engineers:	Latimer Sommers & Associates
Lead:	William Bassette, P.E., LEED AP, and vice president
Product Focus:	SEP4™ 4-in-1 hydraulic, air, dirt and magnetic separator
Challenge:	Water hardness and quality

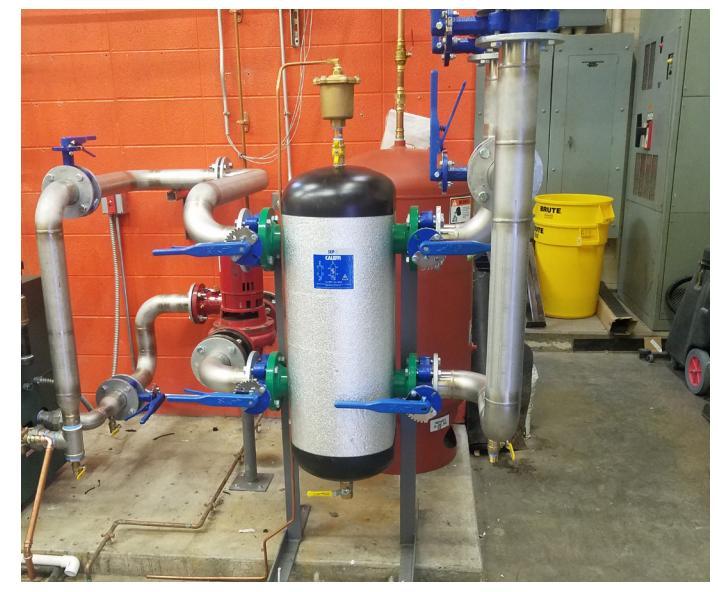
used to conveniently refill the system and reduce the hardness of the new water.

Next, the system was repiped to add a Caleffi SEP4[™]. This 4-in-1 hydraulic, air, dirt and magnetic separator was selected to continuously catch both ferrous and non-ferrous debris left in the system. Equipped with a rare-earth magnet, the SEP4 attracts ferrous impurities with 2-1/2 times the removal performance of a standard dirt separator.

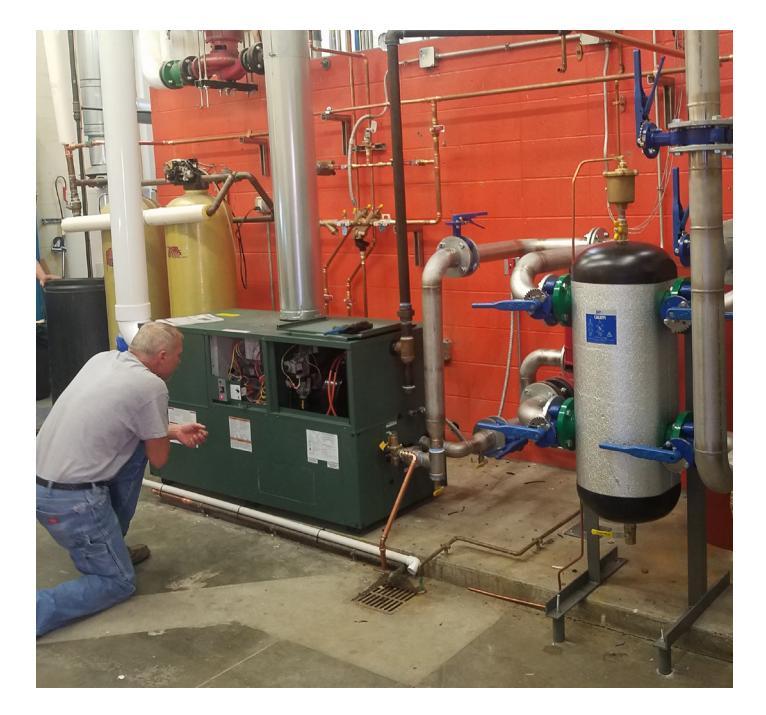
that the existing expansion tank had recently been replaced. The existing piping had a circulator pumping into an expansion tank, causing a problem with the system pressure. To fix this, they increased the pressure and matched the set pressure of the new expansion tank.

Additionally, the SEP4 helps scrub the microbubbles out of the system effectively. Since the system had a VFD driven system pump, the SEP4 also ensured proper primary/secondary piping for the new boiler.

The contractor hired for the repipe has worked extensively with a distillery in the area. Since they wanted to cover all bases with the repipe, stainless steel was suggested for the near boiler piping. They connected the boiler to the Caleffi SEP4 with expertly welded stainless.
